Phase I Inspection Report

Mt. Beacon Reservoir

Hudson River Basin, Dutchess County, New York

30 September 1980

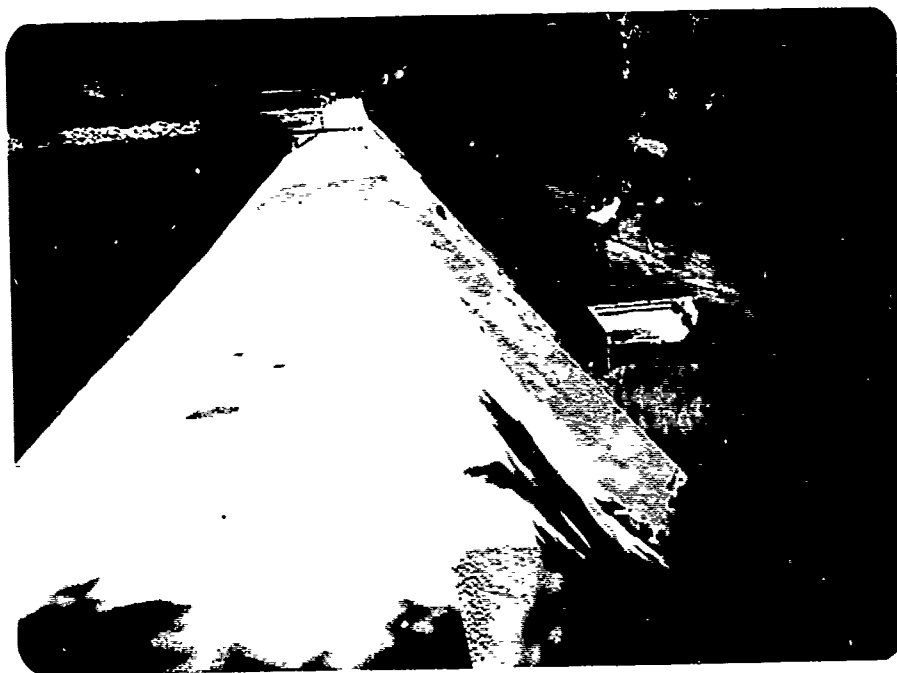
3. VIEW OF SPILLWAY AND DOWNSTREAM OF DAM.
NOTE: VEGETATION AT TOE OF DAM.

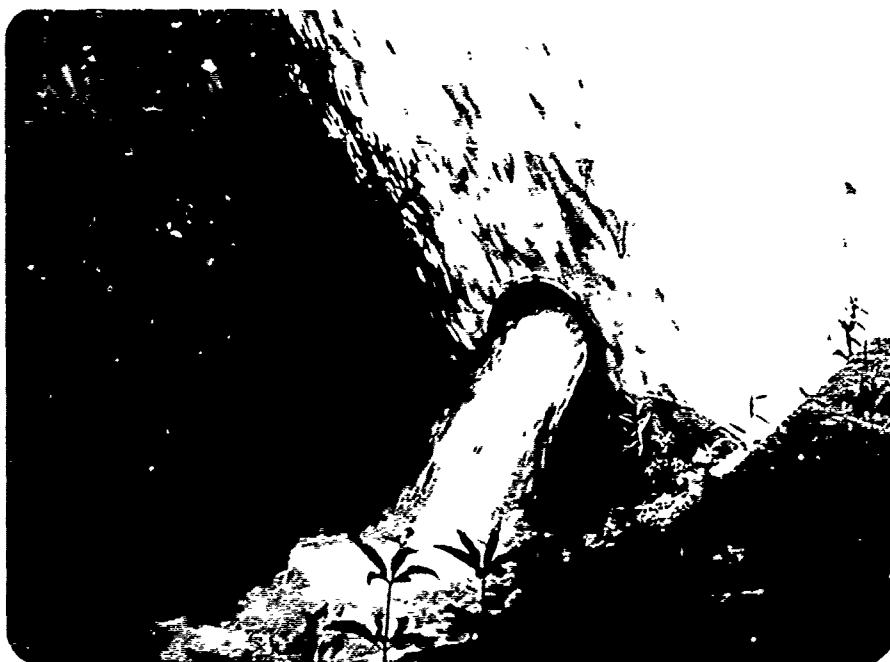
6. VIEW OF RESERVOIR DRAIN OUTLET. NOTE: 6-INCH DIAMETER PIPE NEXT TO DRAIN.
